Community Redevelopment Agency

**CITY OF NEW SMYRNA BEACH
AGENDA MEMORANDUM
COMMUNITY REDEVELOPMENT AGENCY**

The Chamber of Commerce building, located at 115 Canal Street, is in need of exterior repairs in order to “seal the envelope” of the building to prevent further weather damage to both the exterior and the interior. More specifically, the roof, window casings and door jambs leak, the roof does not properly drain, portions of the coquina have deteriorated and small pieces have fallen off, and so forth. The City determined that Phase I of work on the Chamber of Commerce would consist of external restoration, with plans to do interior restoration work during Phase II. The City attained grant funding for Phase I in the amount of \$382,800 through the Volusia County ECHO grant program. These funds are matched by \$191,400 from the Community Redevelopment Agency. Therefore, total project funding available for Phase I is \$574,200.

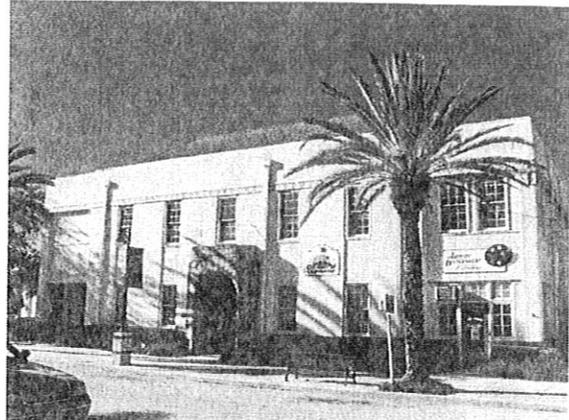
Front (south) façade of Chamber of Commerce building, looking NE. The enclosed second floor porch is visible at left.

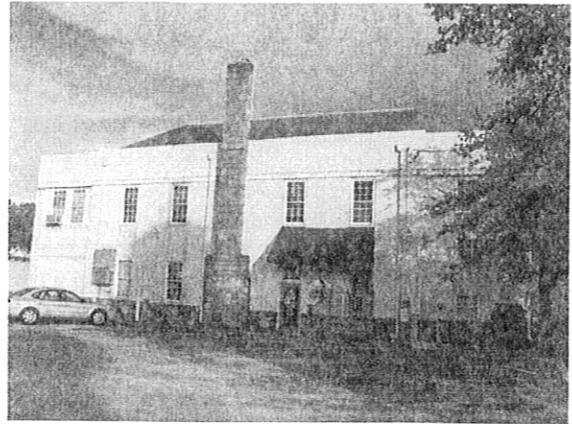
The building suffers from deterioration that is typically associated with deferred maintenance. Exterior window trim and adjacent jamb infill is rotted and roof leaks are evidenced by interior stains. The chimney has pulled away from the building and some stone has weathered or spalled.

Rear (north) façade of building. Coquina rock chimney can be seen at center of building.

Alterations to the structure have negatively impacted the historic characteristics and features of the building. The focus of this phase of the restoration is the exterior envelope, but a number of deficiencies that are outside of this scope will require future attention and are noted herein to allow for simplified future coordination. Restoration of elements on the exterior envelope requiring attention include: roofing, roof drainage, copings, flashing, windows, doors, re-open southwest 2nd floor balcony, remove plywood siding and restore woodwork, restore coquina stone elements, remove north wooden steps, and restore the original window at this door opening.

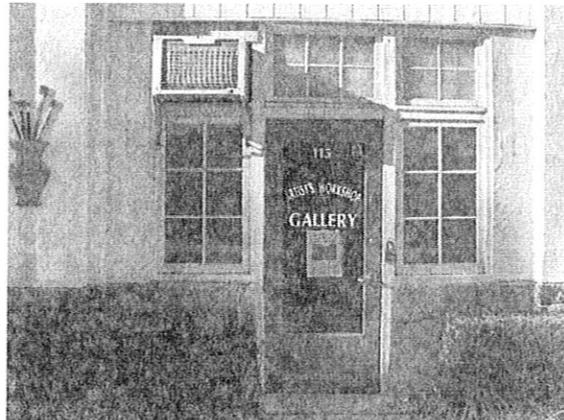
This door at the east side of the front façade leads to a vestibule containing the second floor stair. The casement windows are largely original. All have been painted shut and/or covered.

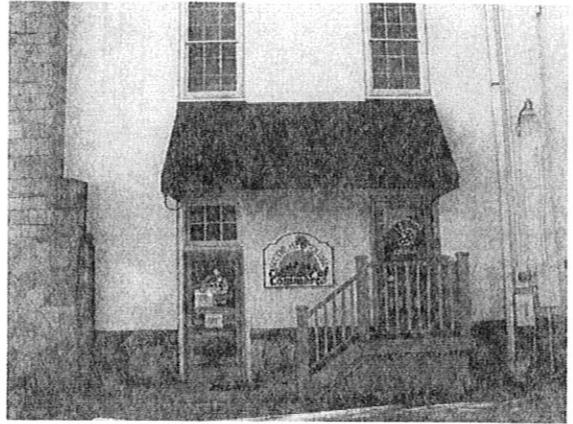
The two remaining doors are on the north side. The westerly of these doors replaced an original window and is accessed by a wooden stair. Below the stair landing is a screened crawl space access. This door serves to access the second floor without entering the lower level lobby. The other door, about 7' east enters the lobby at grade. This door is 2'-10" wide x 6'-8" tall with a 6 light transom that aligns at the top at the historic window head elevation.

Doors at rear of building. The door at right accesses the west side of the building, located approximately 30" above grade. This door was converted from a window. The door at left opens into the main reception area at grade.

We recommend that the exterior door swings be determined based on anticipated occupant loads and code requirements.

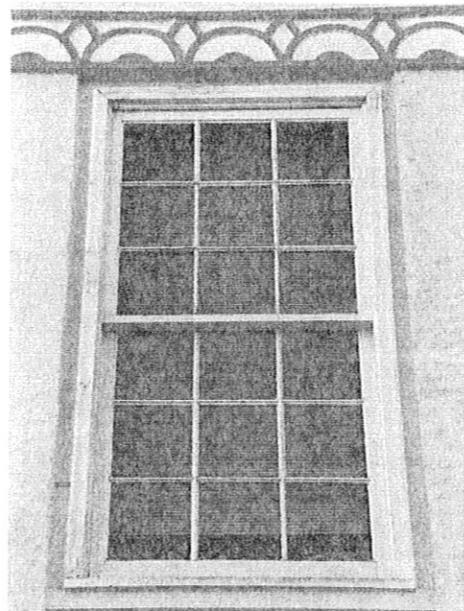
The windows consist of double hungs and casements. The casements are on the east end stair hall and are original to the building. All but two of the double hung windows have been replaced with small units than the original. These replacement units have equal sized 9 lite sashes while the original had unequal sized sashes, 6 lites over 9 lites with individual panels equally sized. Both of remaining historic windows are "interior": a 6 over 6 double hung unit on the second floor on the south wall of the stage that looks into a storage room, originally the second floor porch, and 6 over 9 double hung windows that look onto the east stair landing. There will likely be windows or window sashes buried in walls at these locations.

Typical 9 over 9 wood double hung window. These windows are not original to the building. At some point, smaller windows were installed by furring in the masonry opening with wood siding. This siding is visible around the window. The blue-painted decorative cornice above the window runs around the entire building.

Doors and windows are significant character defining elements and should be accurately restored. In the case of the Southeast Volusia Chamber of Commerce, the wood 6 over 9 sashes should be custom fabricated using historic units as models to ensure an accurate match. Doors should be fabricated to replicate the original units using on site historic units and historic photos to match details. A significant issue will be door swings. With the exception of the door accessing the second floor porch, historic doors swing in, with out-swinging exterior screen doors. Current building codes require that exit doors swing in the direction of exit travel for occupant loads over 50 occupants, which is the case for the Chamber Building.

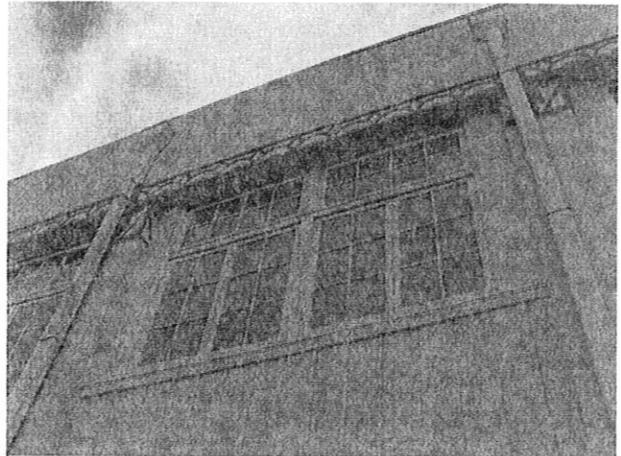
A typical casement window at the east side of the building. These casement windows lined the entire east stairwell at both first and second floors. They are original to the building. The T1-11 siding visible below the window is deteriorated and should be replaced by board and batten siding replicating the original.

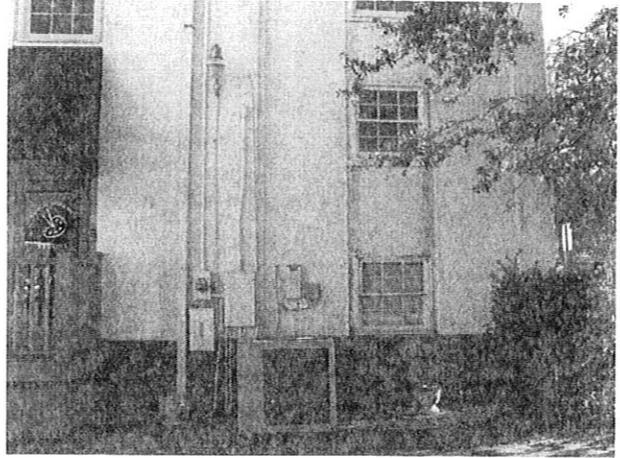
One of the most detrimental modifications to the exterior walls, both visually and physically, are the large number of conduits, wires and condensing lines attached to and penetrating the exterior envelope. Visually, they detract from the historic characteristics and physically they are a source of moisture infiltration.

Detail photo of rear of building, showing the many conduits, condensing lines, lights and electrical panels which cover the building.

The exterior penetrations consisting of conduit, wires, panel boards, condensing lines, and air conditioning units attached to walls must be removed to facilitate the exterior envelope restoration. These items are addressed in detail in the applicable sections that follow.

Alterations to the envelope which require restoration include: restoration of roof drains and leaders, restoration of roof scuppers, repair of wall penetrations, and restoration of board and batten wood panels between the first and second floor windows.

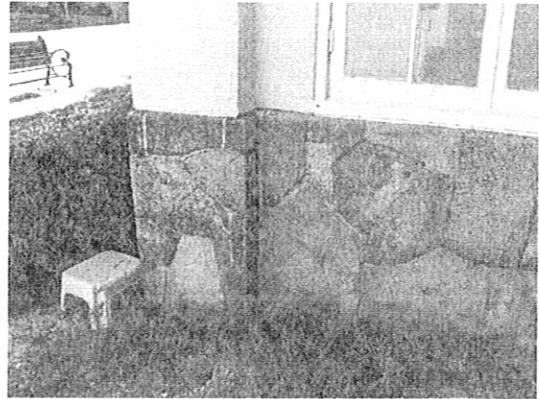
The visible foundation wall is coquina stone, 12 inches thick and serves as a decorative base for the exterior composition. The foundation wall is generally sound with some weathering. There are obvious areas of repointing where the mortar color does not match or the joints were not tooled. There is no evidence of foundation settlement. Most deterioration of foundation stone is limited to surface weathering.

Detail photo of 12" wide coquina rock foundation wall which surrounds the building. This wall is visible at the exterior and on the interior, at the central reception room.

There are minor floor framing repairs noted in the structure report which we recommend complying with. Screened access panels to the crawl space should be fabricated and installed. The southwest opening should be detailed to include a sill.

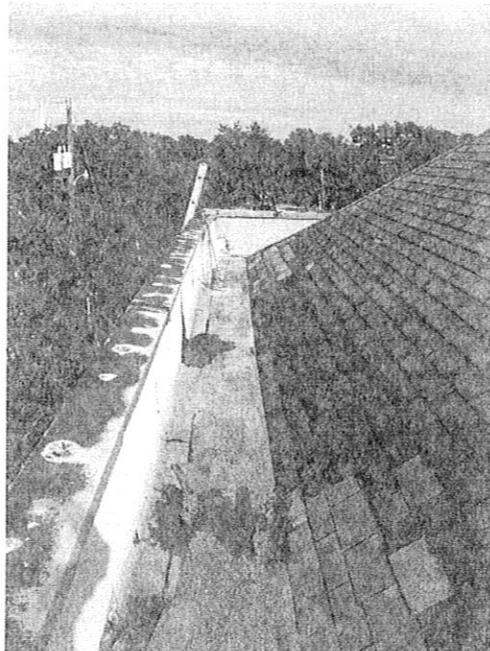
Photo of roof, near NW corner. The hip roof is composed of asphalt shingles. A flat walkway extends around the perimeter of the roof, just behind the parapet. The parapet cap, seen at left, is severely deteriorated. A roof patch is visible in the foreground.

in width as the parapet height increased. The plaster patch for the original roof drain outlet is 55" below the cap flashing. The current scupper is about 29" below the coping for a 26" difference. From the center of the west end around the parapet to the scupper is about 30' and 25' from the centerline of the north side. There are some missing shingles, but no obvious sources of roof leaks on the roof surface. The membrane generally appears water tight, with leaks occurring at parapets and flashing.

We recommend a full roof replacement that incorporates replica shingles on the hipped portion. Additional study or photographs and other documentation is recommended to confirm the material and appropriate details. The historic roof drains should be reactivated, including collection boxes that replicate the original. The collection boxes and downspouts should be fabricated from copper, as should all new parapet cap flashing. The flat portion of the roof should have tapered

polyiso insulation installed to provide positive drainage to the four roof drains. The overflow scuppers should be repaired to match the originals. During design the east and west end scuppers that were a later addition should be analyzed for possible inclusion as overflow protection. However, it is much more important to include positive roof drainage in the design and in all probability these will be covered. The north and south added scuppers will be lost when the proper roof slope is installed. These are non-compatible elements which are negatively impacting the building physically as well as visually.

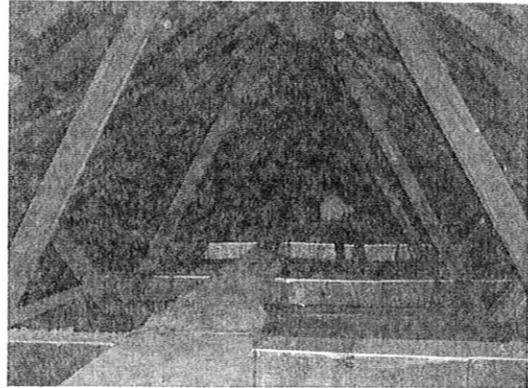
View of attic. The roof consists of trusses, visible in photo, with wood rafters between. Ductwork for the second floor HVAC system is visible at the bottom of the photo. The 1" wood sheathing at the hip roof is generally in good condition.

The attic structure is sound and the timbers show no signs of rot, deterioration or distress. The four original cast iron roof drain pipes are visible in the attic and appear sound. They are set about 24" from the outside face of the wall. The framing around the parapet walkway is flat, so any slope to drains would have been accomplished by overframe. In all likelihood, the current exterior level for scupper drainage is the historic scupper overflow. The apparent roof modification was to abandon the 4" diameter roof drains and use the scuppers to drain the roof, adding six scuppers to the original four.

From the attic, at least one hole where daylight penetrates was located. A piece of roof sheathing was broken off, probably by an impacted missile during a storm.

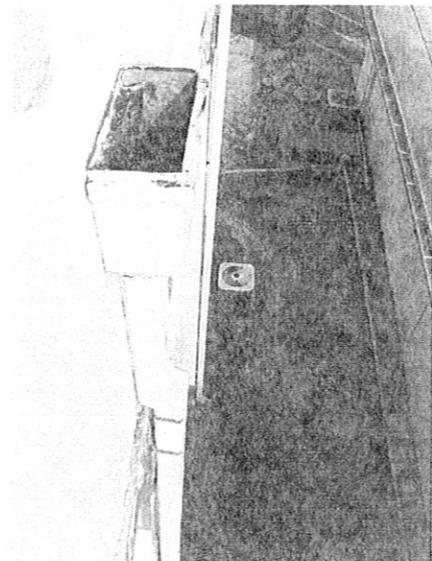
Photo of scupper, collection box and leader at east side of building. This leader is not original to the building.

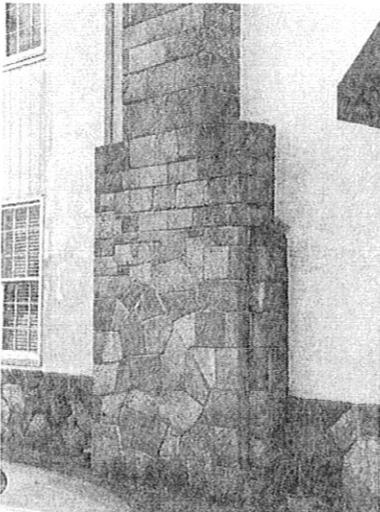
Detail photo of rear chimney of building showing weathered condition. Plant growth can be seen at right of chimney.

Issues involving exterior stone include: plant growth, weathered faces, spalled or chipped corners, and spalling of stone surfaces where conduit or other metals were embedded in the stone. This last issue is most noticeable at the arched entry to the lobby. The original light fixture suspended from the arch was a round

Cleaning stone is often unnecessary and we rarely recommend cleaning. More damage can occur using harmful cleaning techniques or inappropriate chemicals than from hundreds of years of normal weathering. There is surface damage to the stone which is likely the

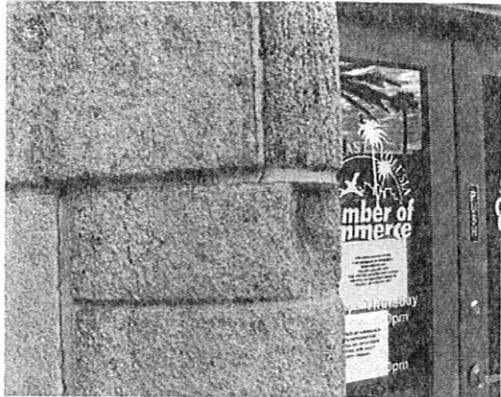
Three detail photos of the coquina stone entry at the front of the building. Top photo shows chipped stone at the side of the arch. The center photo shows spalling at the top of the arch, probably due to corroded metal conduit. The bottom photo shows discoloration from different areas of weathering, as well as spalling near the door frame.

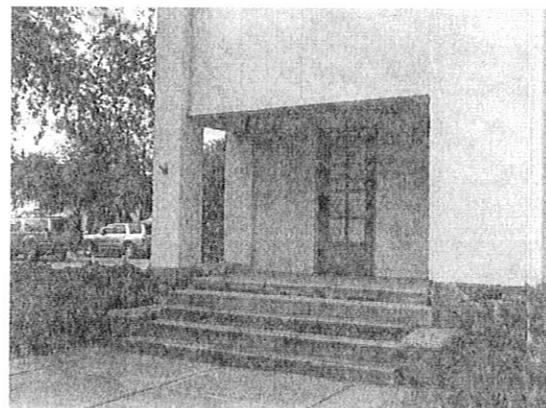
Concrete stair and landing at the southwest porch. This stair, now concrete, was originally coquina stone.

stone. The first tread down from the landing wraps the stone base at the column and is poured on top of the stone cap of the side rail projections. A review of historic photos shows coquina treads and a landing that was likely coquina as well. Three risers from the sidewalk rose between the stone wings with the third tread level with the stone cap. An additional tread ran between the corner column to the building for a total of 5 risers. Using the existing stone cap and existing grade yields risers of 6" and treads of 11" which would place the landing about 2" below the interior finished floor, a very common detail for a porch of that era.

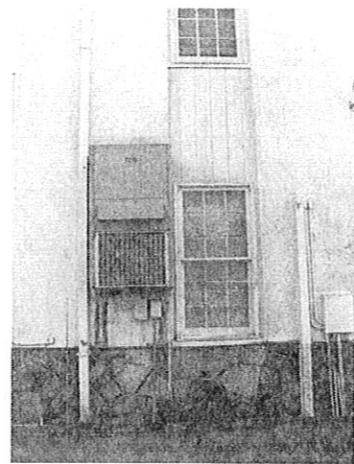
Package air conditioning unit at the rear of the building. The exterior is cluttered with panels, air conditioners, conduit, and telephone lines, all installed haphazardly. Many of these penetrations are leaking.

Ultimately, a full replacement of the mechanical and electrical systems will be required. For this first phase of the project, all exterior electrical, telephone, cable, mechanical, and similar components should be removed. We recommend a new underground electrical service to the building from the existing power pole feeding the building. If allowable under local regulations, the meter and main disconnect would be located on or at the existing utility pole. Alternately, a concrete pole or masonry wall at the northwest property corner can be installed to mount the meter and main disconnect. Power can be fed from the west end crawl space

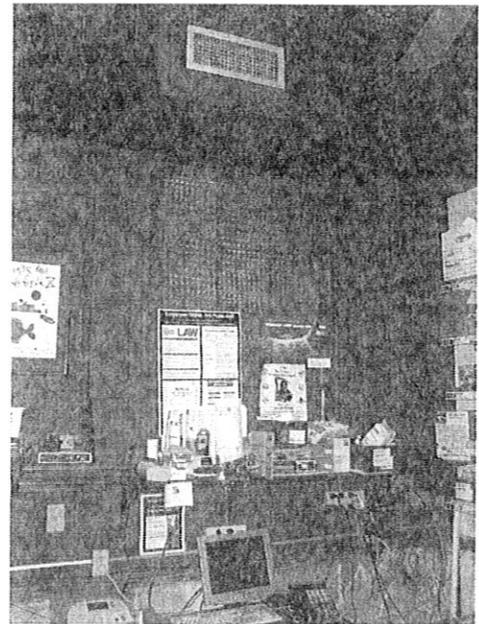
Office on first floor of building. Electrical and telephone conduit lines the walls. A package unit at the exterior wall feeds air into the soffits seen above.

The thru wall package A/C units should be removed. As an interim measure, new air handling units should be installed inside the building and tied to existing ductwork: the west unit in the board room closet should be ceiling hung, and the east unit at the northeast corner office. Condensing lines can be fed through the crawl space for the west unit and under the stair landing for the east unit.

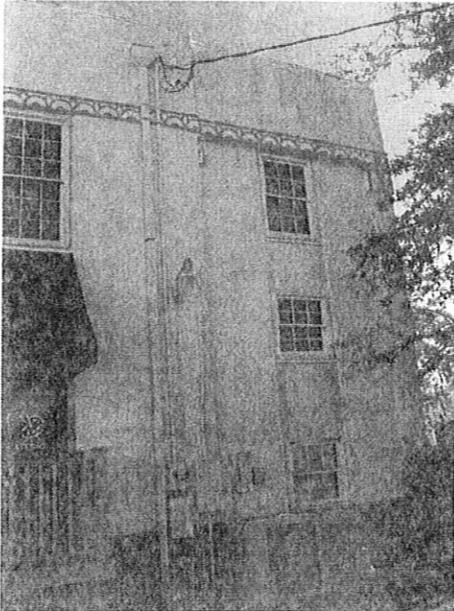
Main electrical drop at north façade,
feeding meter and various subpanels.
