Historic New Smyrna Beach Preservation Commission

# Interoffice Memorandum City of New Smyrna Beach

To: Historic New Smyrna Beach Preservation Commission (HPC)  
From: Jake Baker, Planner  
Subject: Demolition Request for Structure Located at 206 Esther Street  
Date: January 13, 2011

To: Historic New Smyrna Beach Preservation Commission (HPC)  
From: Jake Baker, Planner  
Subject: Demolition Request for Structure Located at 217 Esther Street  
Date: January 13, 2011

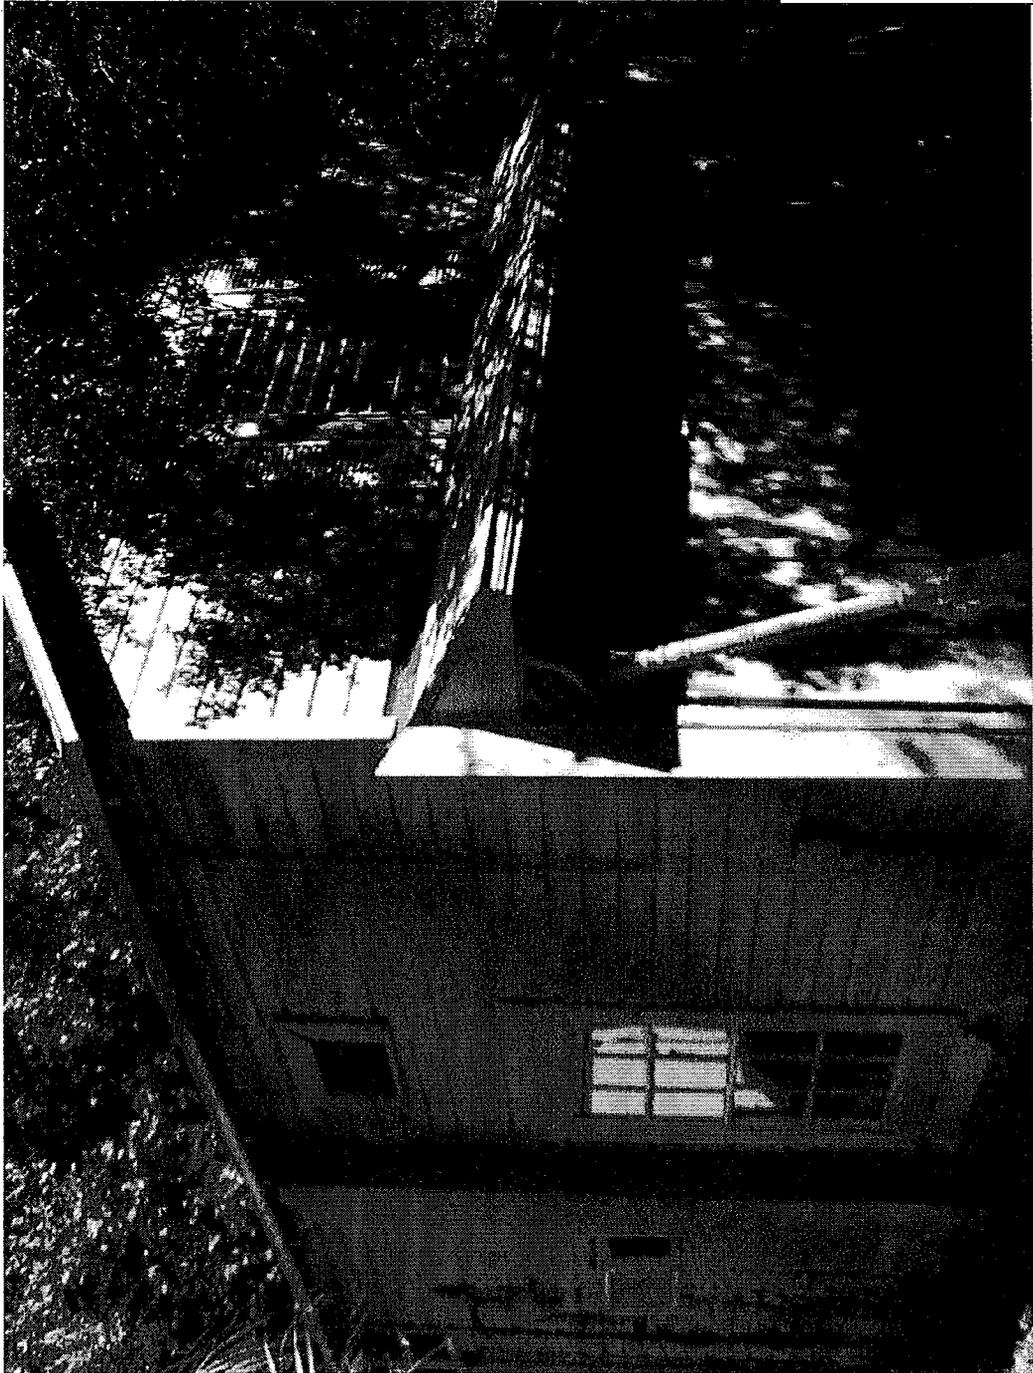
1. The building located at 206 Esther Street was built in the Frame Vernacular style in approximately 1920, according to Florida Master Site File records. According to the property report written by Sid Corhern, a local Historic Preservation Architect, there was an addition added to the structure that same year. An 11' X 10' addition was added in 1995 to the east side of the structure. Please see **Exhibit A** recent pictures of the building, including both exterior and interior pictures.

4. The exterior has many instances of visible rot and missing boards. While the exterior and interior of the structure could most likely be renovated, the lack of functionality in the interior does not warrant restoration.

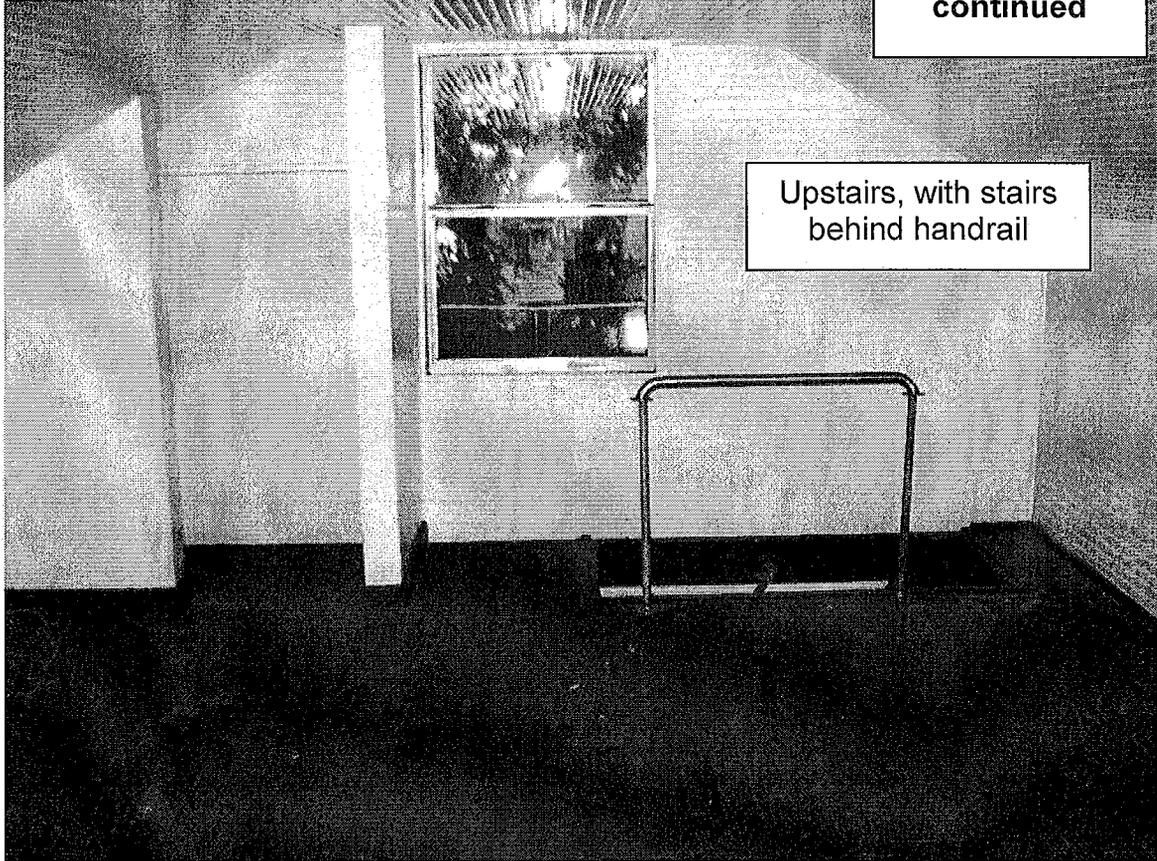
2. Please see **Exhibit B** for a copy of Sid Corhern's property report.
3. The interior of the house is not very functional. The ceilings on both floors are very low. The staircase ends approximately one foot from the exterior wall, where the ceiling is sloped to such an extent that a man of average height can't even come close to standing up straight. It is not particularly safe for anyone to attempt descending the stairs, as they are extremely steep and the handrail is not in an accessible location for the first four of five steps going down.

Upstairs, with stairs  
behind handrail

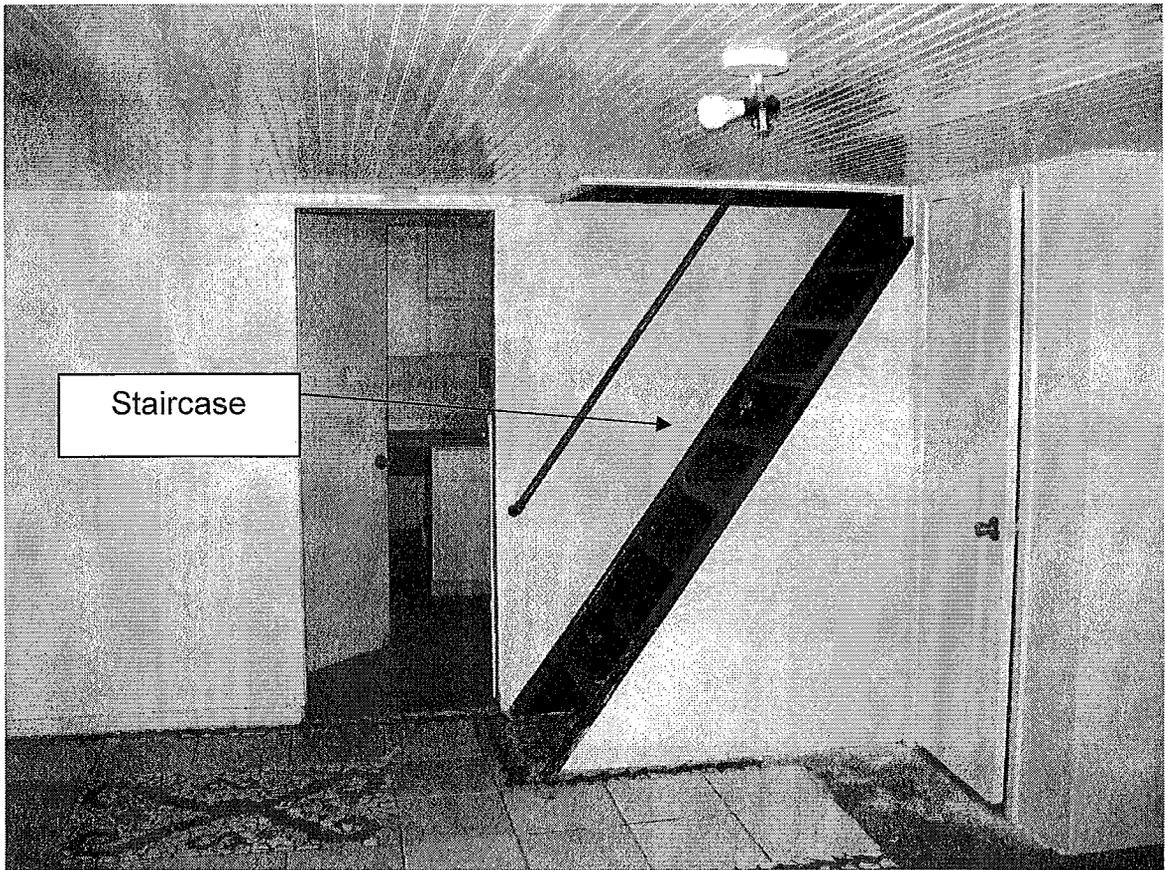
Staircase

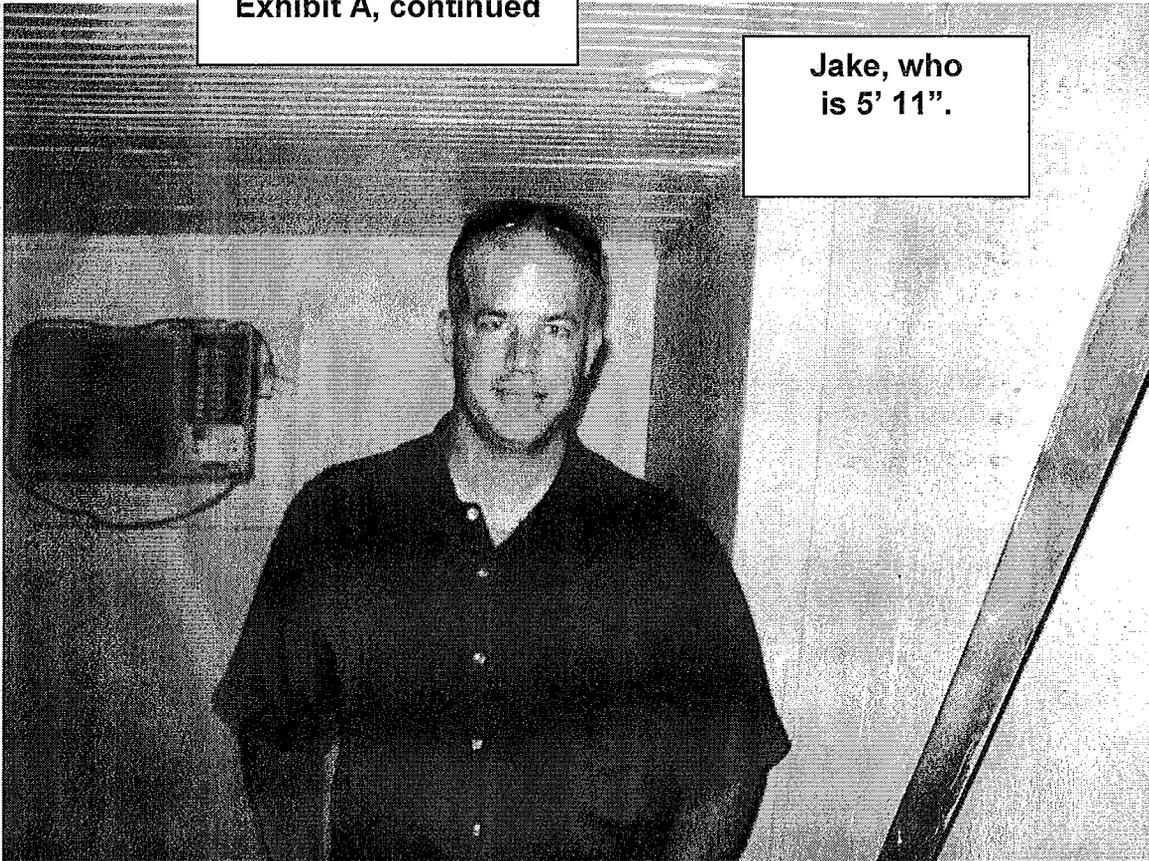
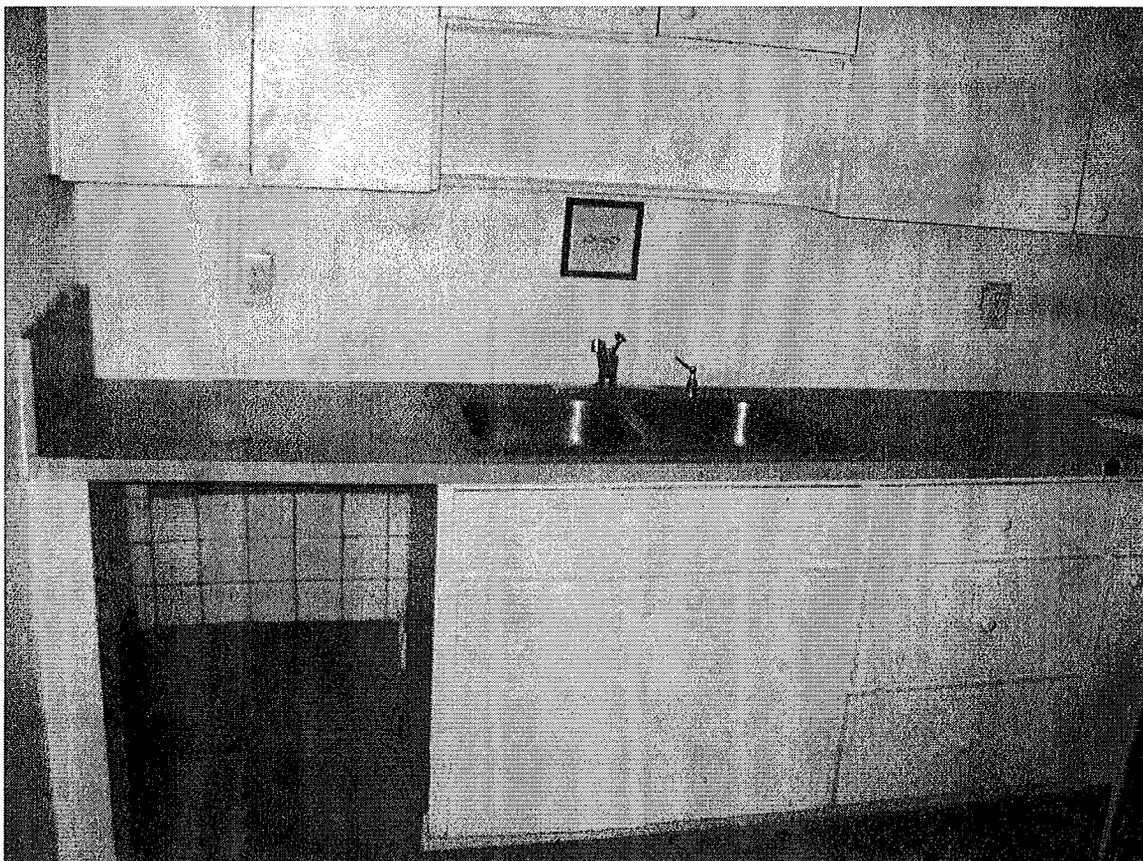
**Jake, who  
is 5' 11".**

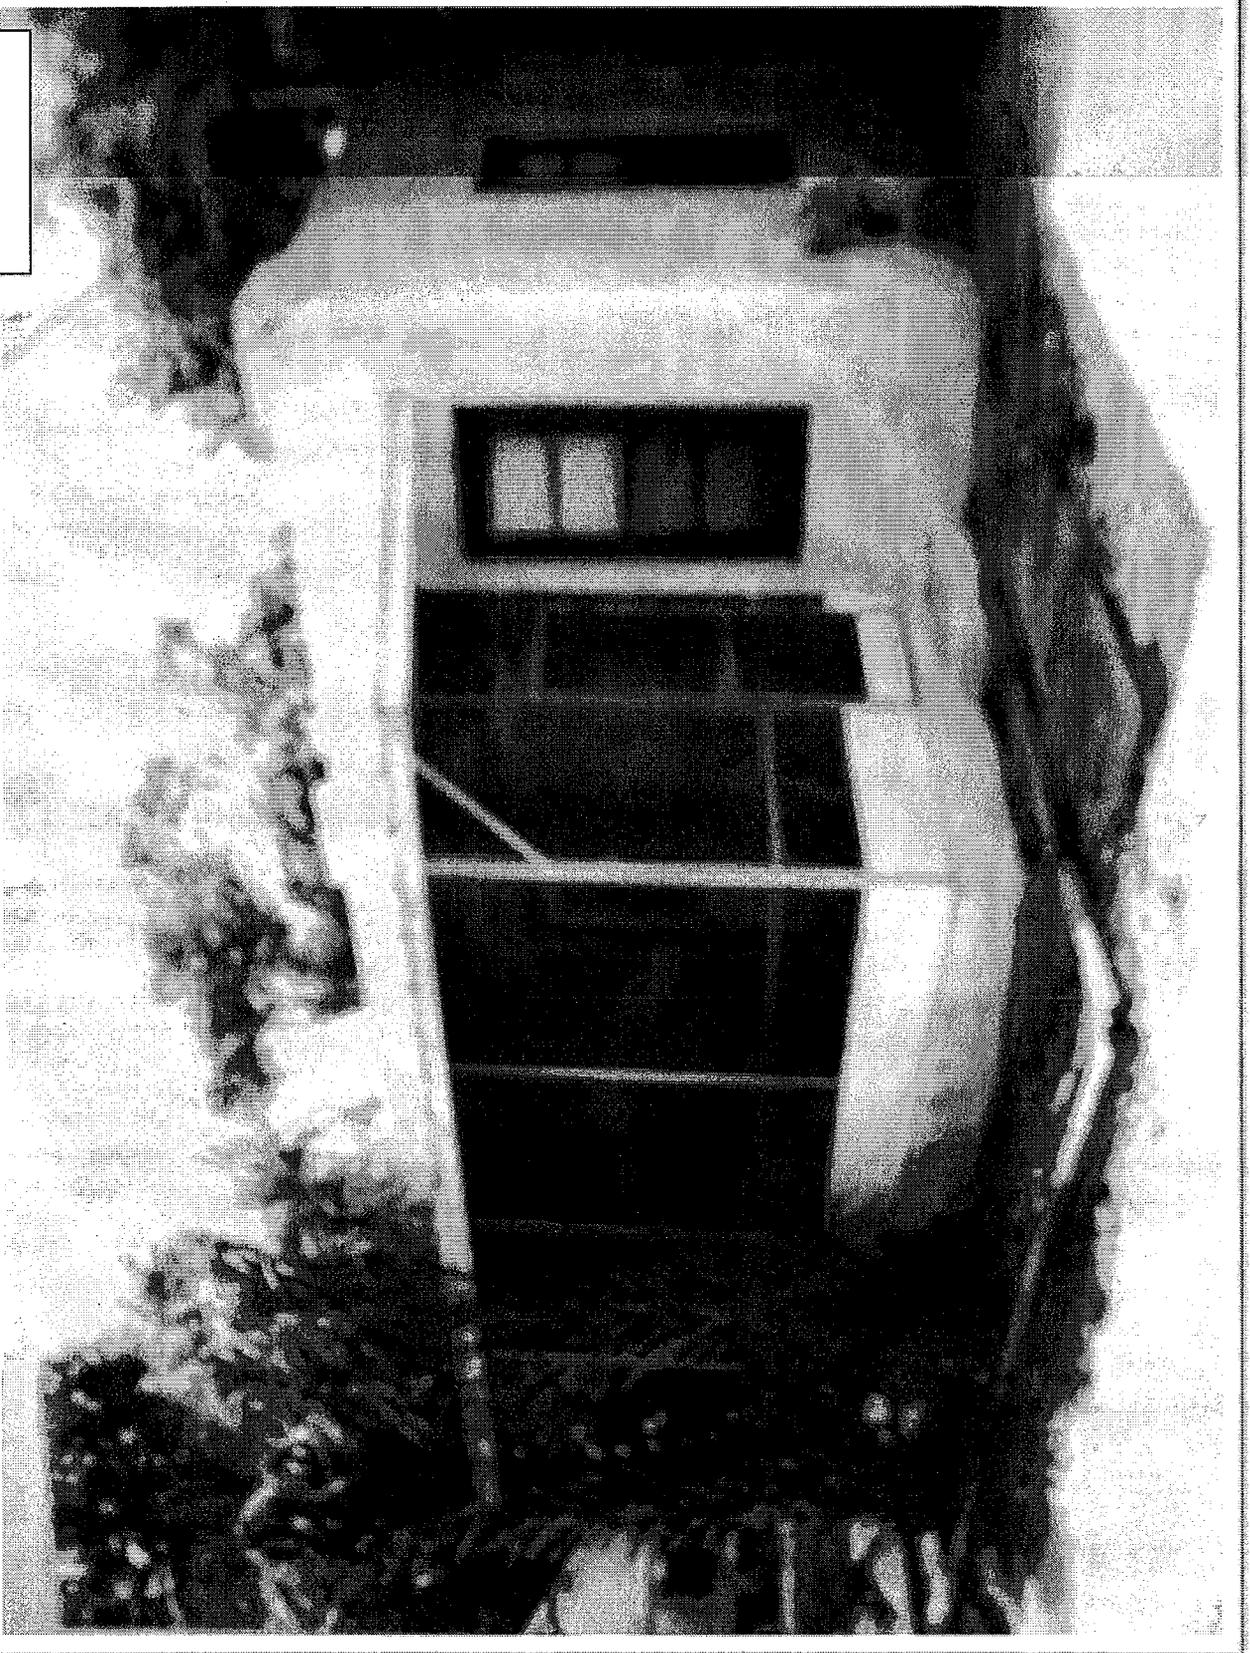
Exhibit A

1. The building located at 217 Esther Street was built in the Mediterranean style in approximately 1920, according to Florida Master Site File records. When the Coronado Beach Historic District was first established in 1997 there was a simple screened-in front porch on the front of the house which has since been removed.

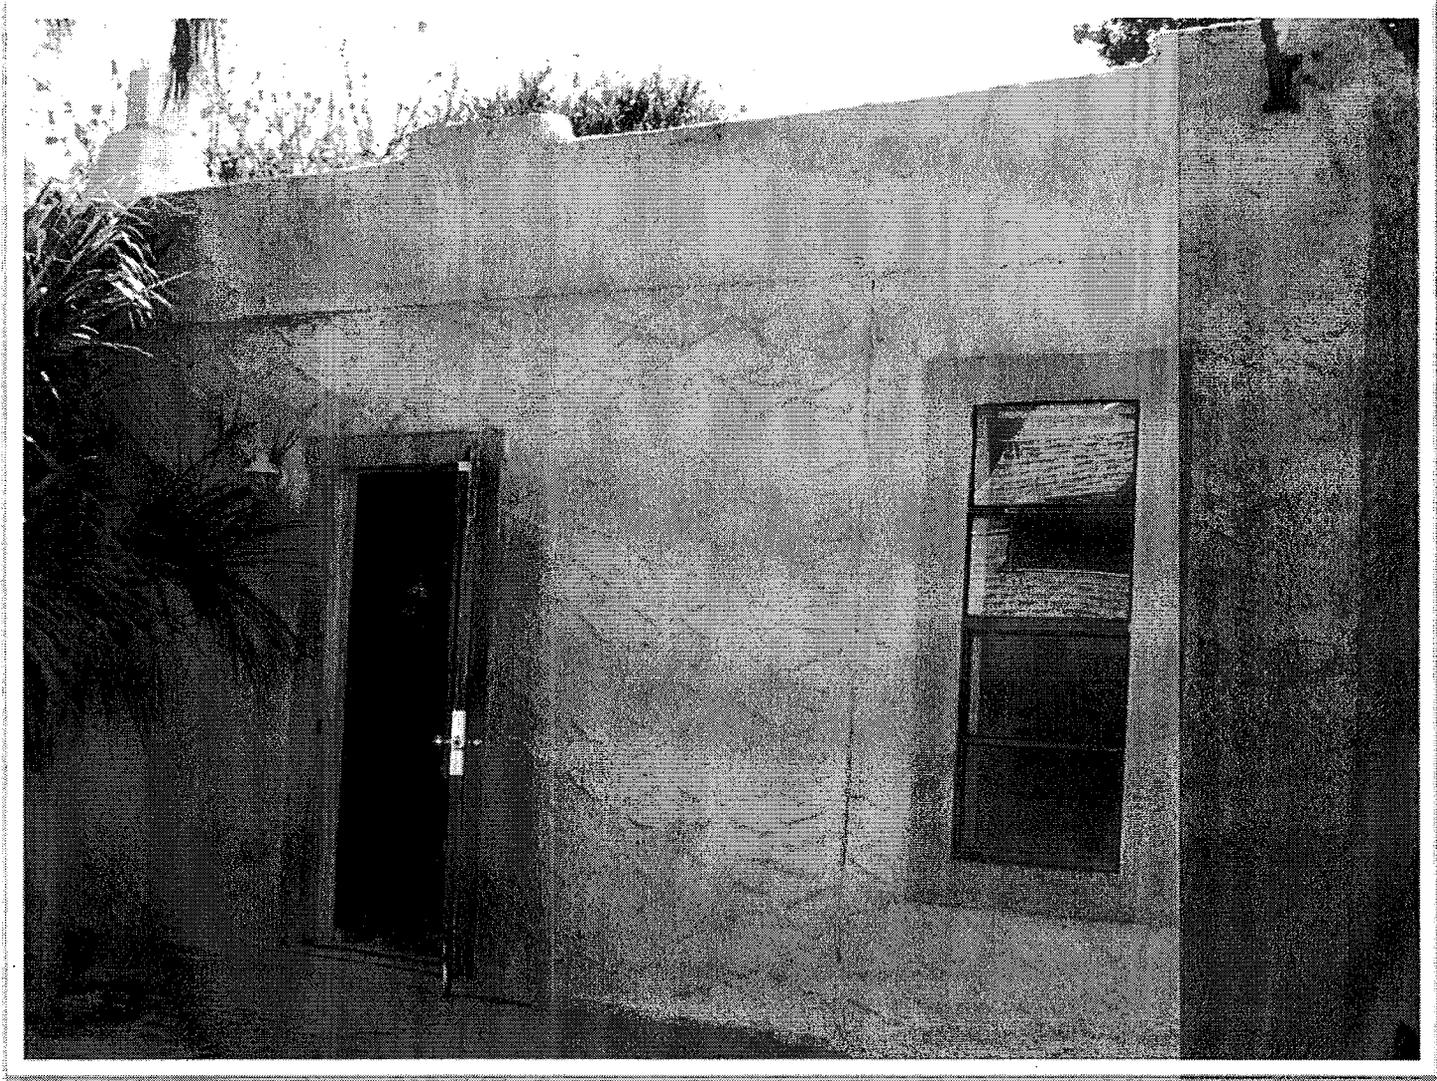
Exhibit B

Please see **Exhibit A** for a copy of the picture. Please see **Exhibit B** for recent exterior pictures.

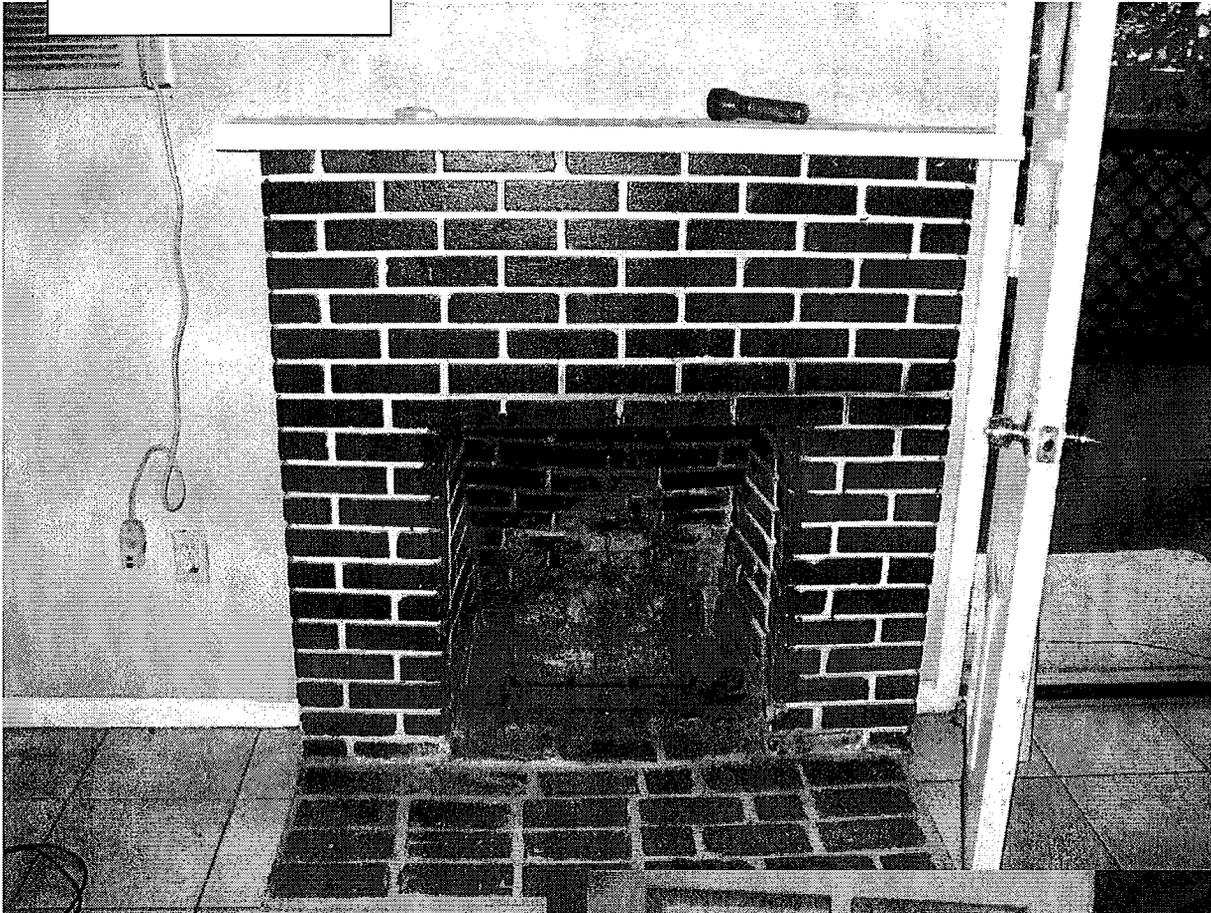
Original fireplace

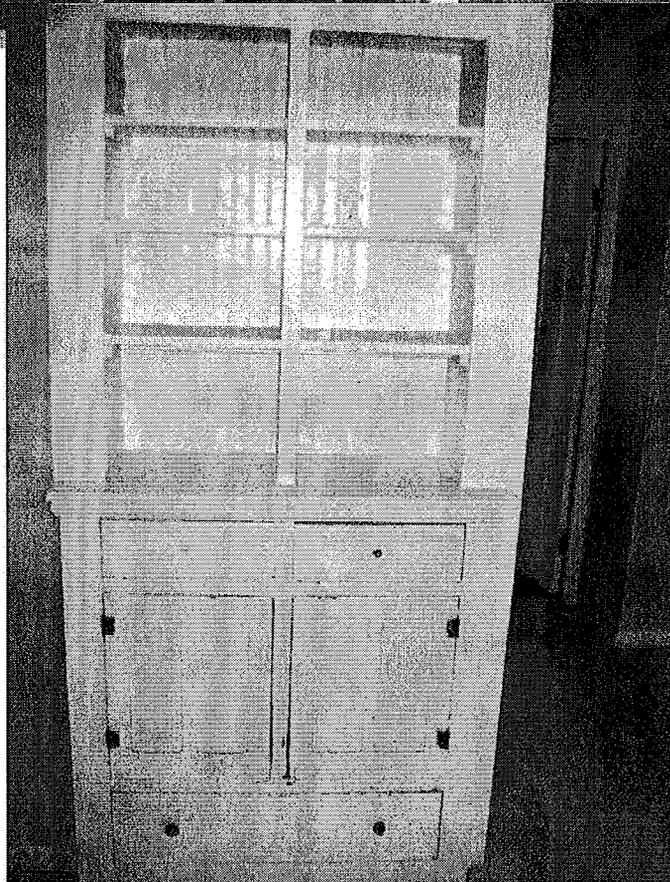
Built-in cabinet

**Interior:** The interior of the building has been completely remodeled. The only remaining original feature is the built-in cabinet in the dining area. All wall and ceiling finishes have been removed. The floor finishes in the kitchen, dining, living and bathroom have been covered with new tile flooring. The bedrooms and closets are covered with carpet. The laundry room floor is bare to plywood subfloor. The electrical system was upgraded and new insulation has been added to the walls and ceilings. The bathroom has been revised and is in poor condition and substandard in size. The plumbing system has been upgraded. The HVAC system is a single in-wall air conditioner located in the living room. There were some dark stains or mold located in the front closet and bedroom. Upon removal of some of the ceiling and wall finishes no mold was present behind the finishes and there was no smell of mold present. The overall condition of the interior space is in fair condition.

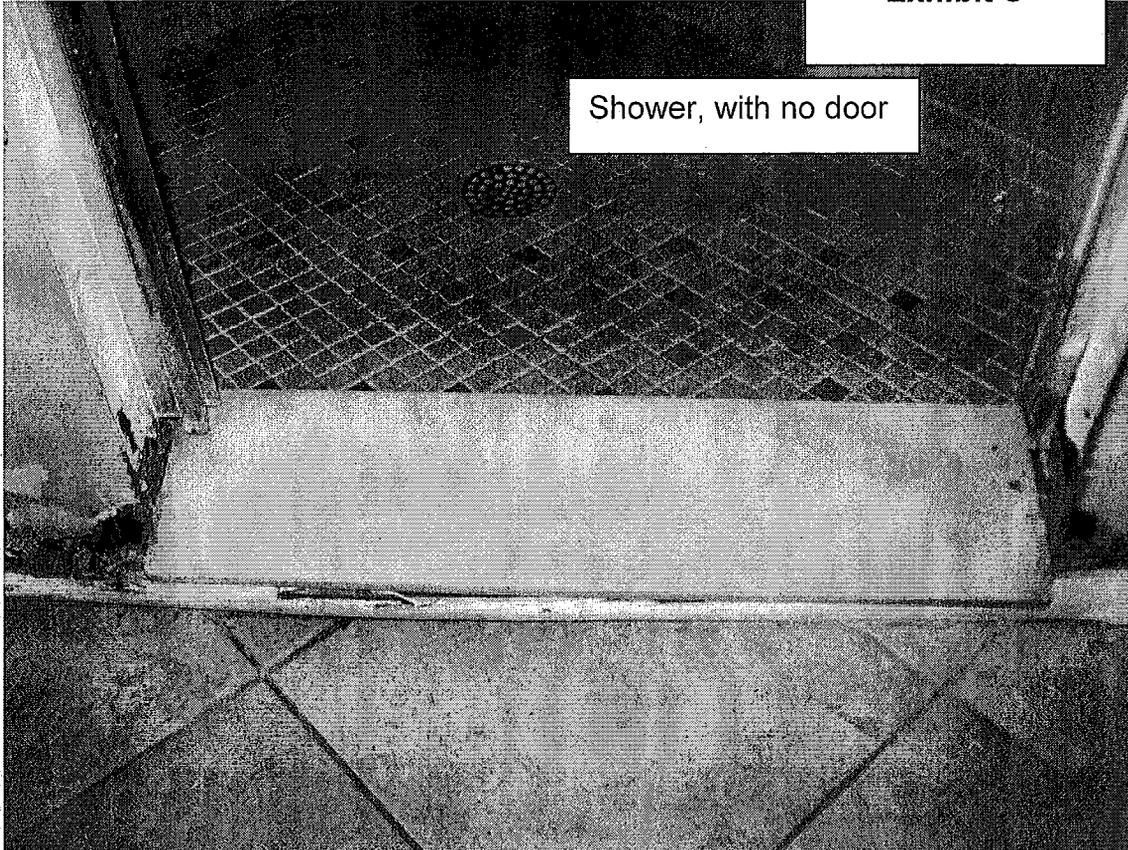
2. The interior of the house has a few areas that have deteriorated, but overall the interior of the house is in decent condition. The shower area has some visible rot, and there is also some rot above the front door. However, these problems are repairable. Please see **Exhibit C** for some pictures of the interior.

Shower, with no door

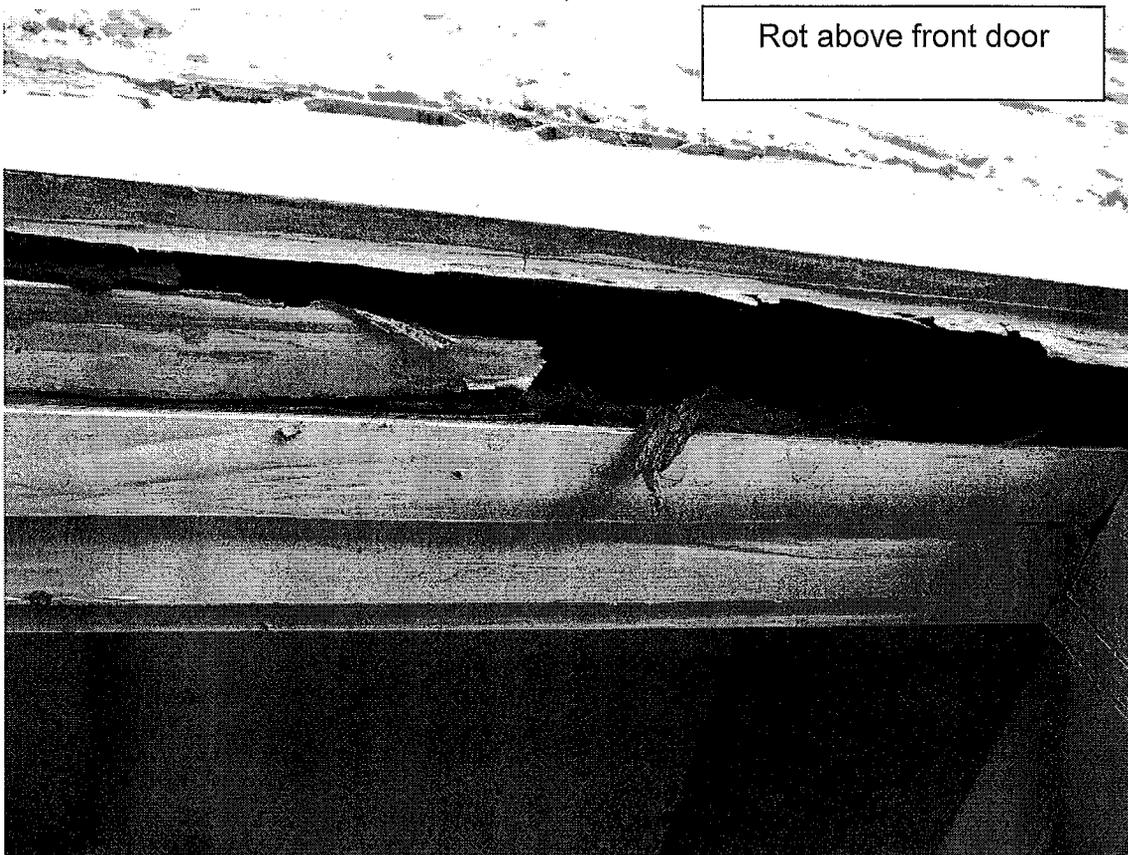
Rot above front door
