Community Redevelopment Agency

**CITY OF NEW SMYRNA BEACH
AGENDA MEMORANDUM
COMMUNITY REDEVELOPMENT AGENCY**

The Chamber of Commerce building, located at 115 Canal Street, is in need of exterior repairs in order to “seal the envelope” of the building to prevent further weather damage to both the exterior and the interior. More specifically, the roof, window casings and door jambs leak, the roof does not properly drain, portions of the coquina have deteriorated and small pieces have fallen off, and so forth. The City determined that Phase I of work on the Chamber of Commerce would consist of external restoration, with plans to do interior restoration work during Phase II. The City attained grant funding for Phase I in the amount of \$382,800 through the Volusia County ECHO grant program. These funds are matched by \$191,400 from the Community Redevelopment Agency. Therefore, total project funding available for Phase I is \$574,200.

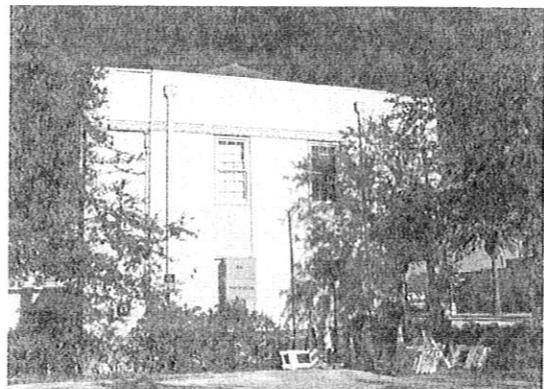
West exterior façade of building. The SW porch is visible at right. The porch is enclosed at the second floor. An asphalt parking lot abuts the building on this side. The city is storing equipment in this area. Landscaping is mostly shrubs and mature live oaks.

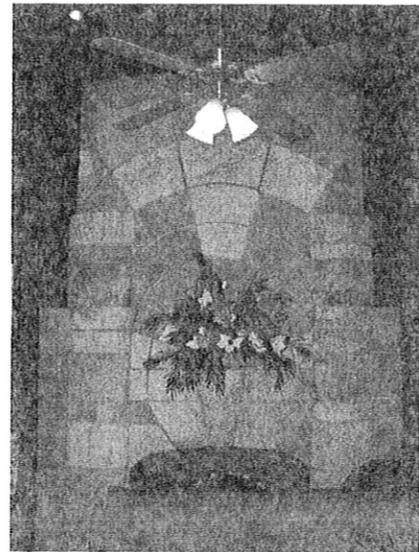
Coquina rock chimney at central reception room, first floor. Coquina is found both at the interior and exterior of the building and is a strong design element. The interior coquina stone is in excellent condition.

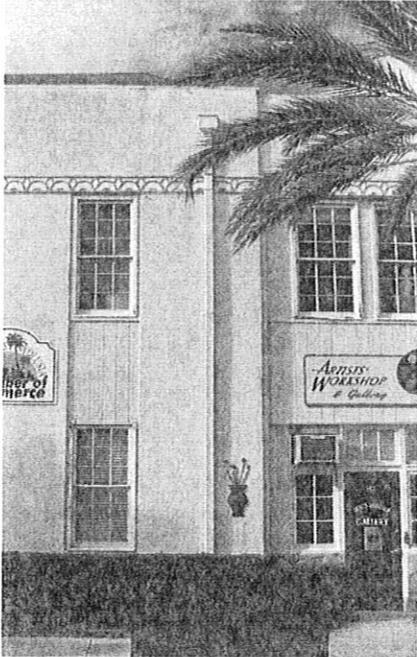
Partial view of front of building. The T1-11 siding between the first and second floor windows is leaking. The siding should be removed and replaced with board and batten siding matching the original.

siding should also be removed to re-expose the west balcony, returning the building to its historic configuration. The guardrail of this balcony consists of the board and batten siding described above.

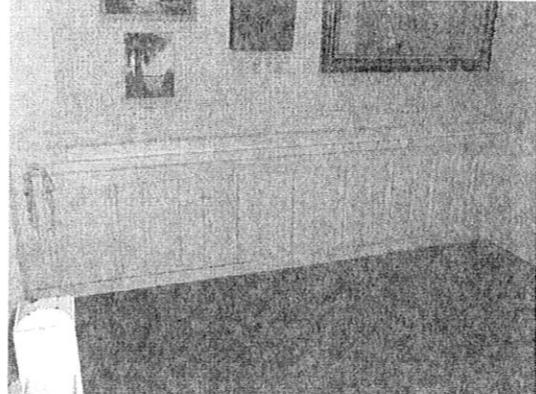
Original board and batten siding in the second floor interior stair vestibule. The historic siding between the windows on the exterior very likely matched this siding, and can be used to replicate it.

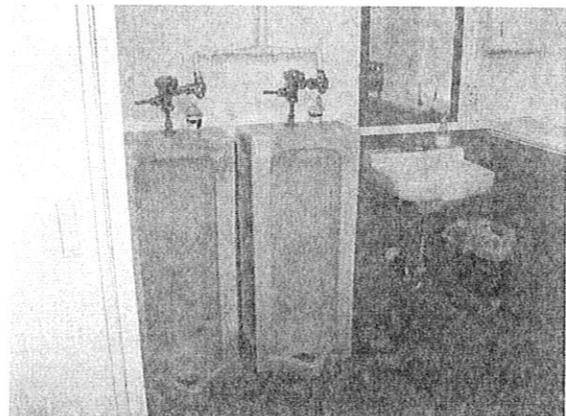
The men's restroom at the first floor. The plumbing fixtures probably are original.
